REPORT TO MCDONALD PUBLIC PARK ENDOWMENT TRUSTEES – 29 MARCH 2021

REQUEST FOR FUNDING – REPAIR WORKS TO FLOOD DAMAGE AT MODLEY BURN

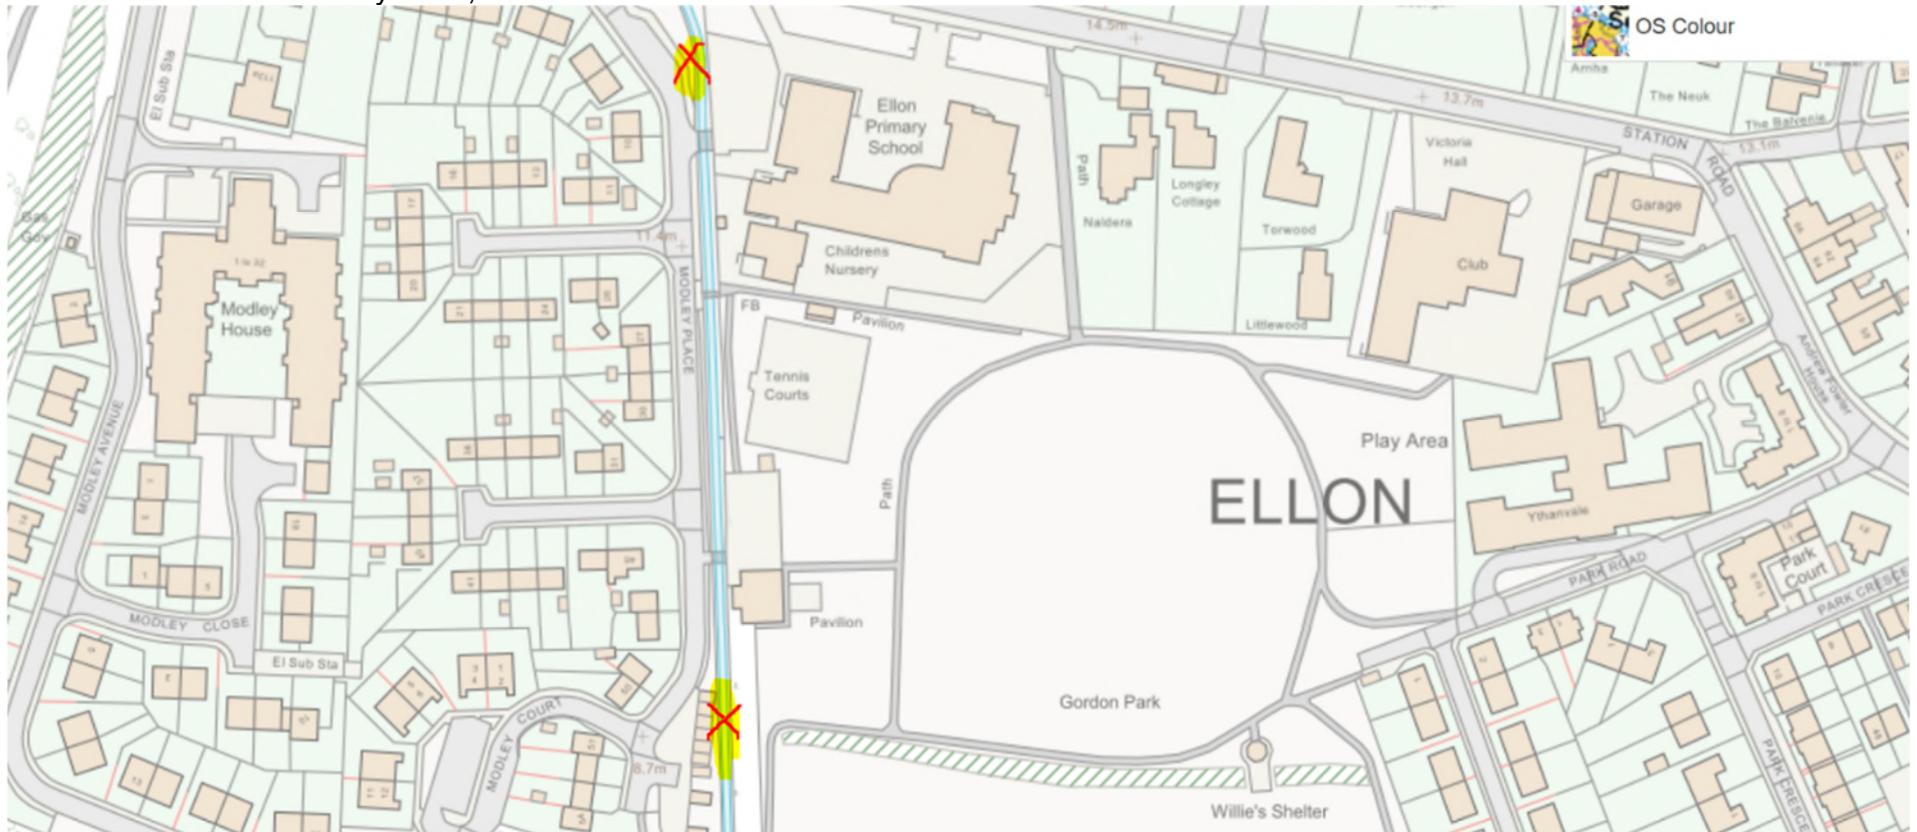
Appendix 1

- 4.1 Landscape Services have found there to be two sections of the burn which have been damaged by flood waters, which could be considered to be reportable.
- 4.2 The stone built canalised walls of the burn have been washed away. These two areas of erosion are highlighted at **Appendix 1** of the report.
- 4.3 The walls will need to be rebuilt in order to stem further erosion.
- 4.4 No permission from Scottish Water will be required as it is intended to repair the walls like for like.

Areas of Erosion at Modley Burn, Ellon

- 4.5 The area which is near to Ellon Primary School is likely to be straight forward, with stones being re-laid into their original position using a lime sand and cement mortar mix.

- 4.6 The area which is near to the Gordon Park Pavilion will need to have a temporary concrete tube placed in the burn to direct water away from the working area whilst the rebuilding of the wall takes place.

- 4.9 The proposed wall will be constructed of natural stone, in-keeping with the existing construction. The wall will be rebuilt using a lime, sand and cement mortar mix.
